Report of
Dam Safety Assessment of Coal Combustion
Surface Impoundments

Kentucky Utilities,
a wholly owned subsidiary of
LG&E and KU Energy LLC

Green River Station, Central City, KY

AMEC Project No. 3-2106-0177-0002

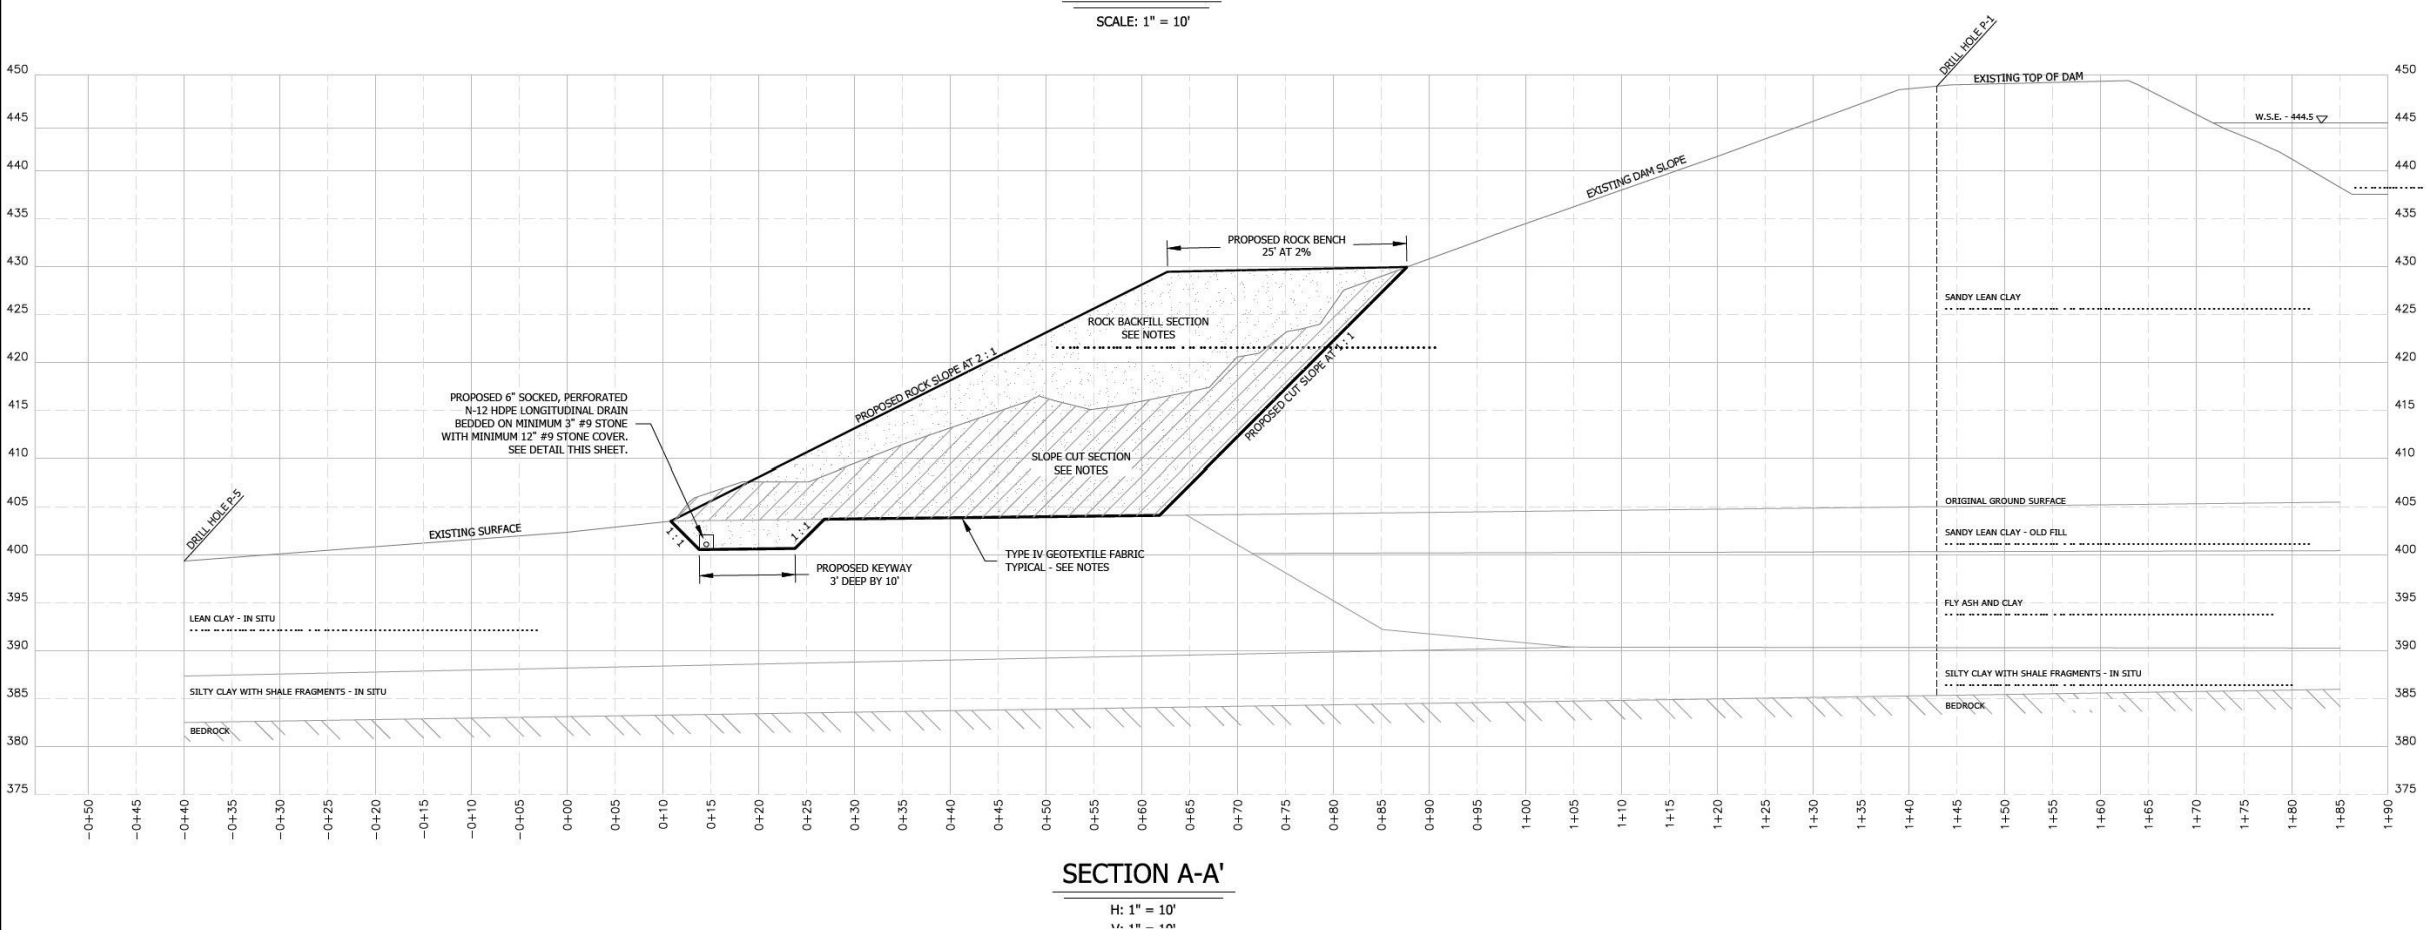
It is AMEC's understanding that the southern embankment of Ash Treatment Basin #1 southern has experienced two slope failures. During the site investigation, AMEC observed a buttress had been constructed on the downstream slope of the dam beginning approximately 200 feet northeast of piezometer P3A. This structure is not shown on the original H.C. Nutting drawings and no other records could be located. However, it is known to have been constructed to repair a previous slope failure. The second slope failure occurred in November 2009. A July 14, 2010 report entitled *Final Geotechnical Report, Main Ash Pond, Slope Stability Analysis and Repair, Green River Station*, prepared by Associated Engineers, Inc., discusses the stability of the entire Main Ash Pond dam along with analysis and design recommendations specific to the recent (2010) slope repair activities. Within the report the slope failure cause was described as follows;

Based on the available data, the probable triggering mechanism of the slope failure was excessive moisture originating from a combination of factors including subtle grading at the top of the dam which directs drainage down the slope in this area, and possible focused surface and subsurface drainage along the base of the dam from the northeast due to topographic influence. Rutting and surface scaring that appeared to have occurred during mowing operations, along with

poor vegetative cover conditions were also probable causation factors. High moisture conditions appeared to be restricted to a limited area in the outer portion of the dam material near the base and did not extend into the interior of the dam construction material. The lower portions of the fly ash and underlying dark grayish brown silty clay were wet and exhibited N-values of 6 to 8. Moisture may be contributed by these units but they were not part of the existing slump feature.

The southern slope of the Main Ash Pond was repaired in May and June of 2010 by excavating and removing loose materials and reconstructing the slope with rock. The recommendations were outlined in Associated Engineers report and are summarized below.

1. Excavate the cut slope on a 1:1 slope and reconstruct with rock on a 2:1 slope.
2. Place Geotextile Fabric, Type IV on excavated soil area meeting the requirements of Section 843, Type IV, of the current edition of the Kentucky Transportation Cabinet, Standard Specifications for Road and Bridge Construction (Appendix E). Install Geotextile Fabric according to Section 214 of the Standard Specifications for Road and Bridge Construction (Appendix E). Prepare the surface to a smooth condition, free of obstructions, debris, or sharp objects that may puncture the fabric. Place the fabric smooth and free of tension, stress, folds, wrinkles, or creases. Do not operate equipment directly on the fabric. Overlap strips at least 18 inches. Place transverse laps so the upslope strip laps over the downslope strip. Install fastener pins through both strips of overlapped fabric at no less than 5-foot intervals along a line through the midpoint of the overlap, and at any other locations as necessary to prevent any slippage of the fabric. Place fabric with the long dimension parallel to the long dimension of the section to be covered.

PLACE GEOTEXTILE FABRIC, TYPE IV ON EXCAVATED SOIL AREA MEETING THE REQUIREMENTS OF SECTION 843, TYPE IV, OF THE CURRENT EDITION OF KENTUCKY STANDARD SPECIFICATIONS FOR ROAD AND BRIDGE CONSTRUCTION. INSTALL GEOTEXTILE FABRIC ACCORDING TO SECTION 214 OF THE STANDARD SPECIFICATIONS FOR ROAD AND BRIDGE CONSTRUCTION. PREPARE THE SURFACE TO A SMOOTH CONDITION, FREE OF OBSTRUCTIONS, DEBRIS, OR SHARP OBJECTS THAT MAY PUNCTURE THE FABRIC. PLACE THE FABRIC SMOOTH AND FREE OF TENSION, STRESS, FOLDS, WRINKLES, OR CREASES. DO NOT OPERATE EQUIPMENT DIRECTLY ON THE FABRIC. OVERLAP STRIPS OF FABRIC AT LEAST 18 INCHES. PLACE TRANSVERSE LAPS SO THE UPSLOPE STRIP LAPS OVER THE DOWNSLOPE STRIP. INSTALL FASTENER PINS THROUGH BOTH STRIPS OF OVERLAP FABRIC AT NO LESS THAN 5-FOOT INTERVALS ALONG A LINE THROUGH THE MIDPOINT OF THE OVERLAP, AND AT ANY OTHER LOCATIONS AS NECESSARY TO PREVENT ANY SLIP OF THE FABRIC. PLACE FABRIC WITH THE LONG DIMENSION PARALLEL TO THE LONG DIMENSION OF THE SECTION TO BE COVERED.

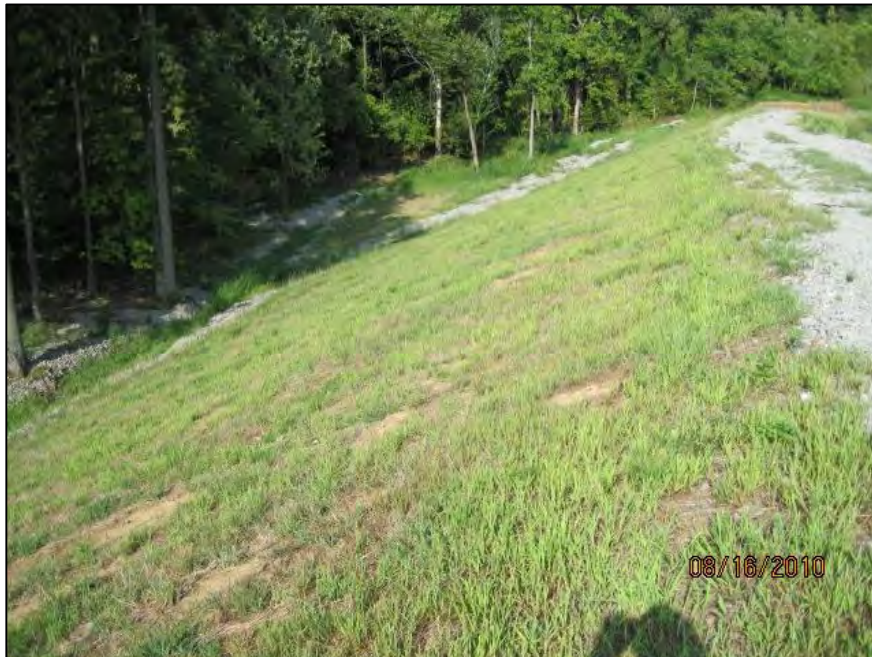
M-2

LOOKING NW AT WEST DIKE - CREST AND DOWNSTREAM SLOPE, SPARSE GRASS COVER

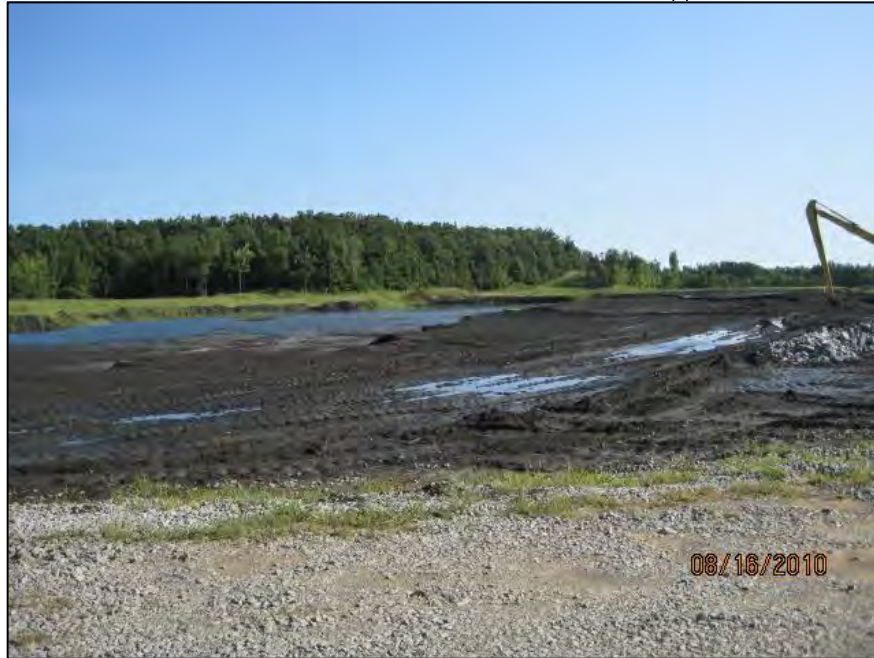
M-3

**LOOKING NW FROM WEST END OF SOUTH DIKE -
ASH STACKED TO NEAR CREST OF SOUTH DIKE**

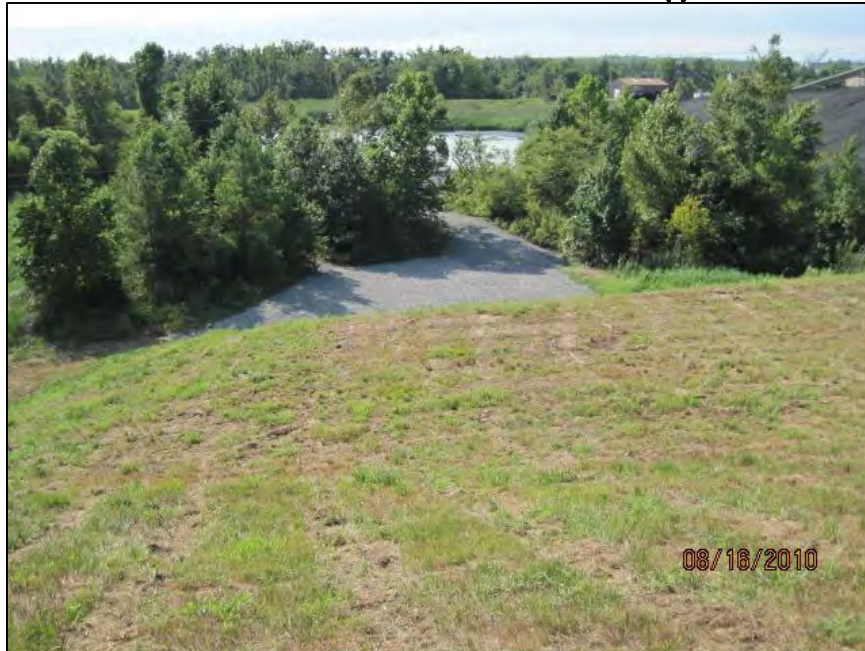
M-9

LOOKING S FROM SOUTH DIKE - AREAS WITH SPARSE GRASS ON DOWNSTREAM
CREST, WEST BUTTRESS, AND COAL RUNOFF POND IN BACKGROUND

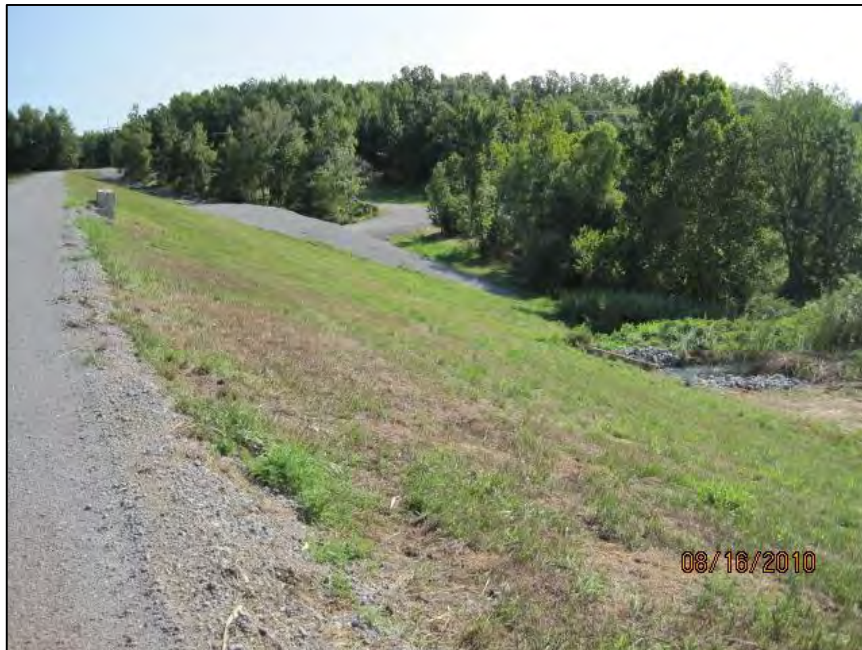
M-12

**LOOKING E FROM SOUTH DIKE - AREAS OF SPARSE GRASS COVER, PIPE OUTLET
OF OUTLET STRUCTURE ON RIGHT, AND EAST BUTTRESS**

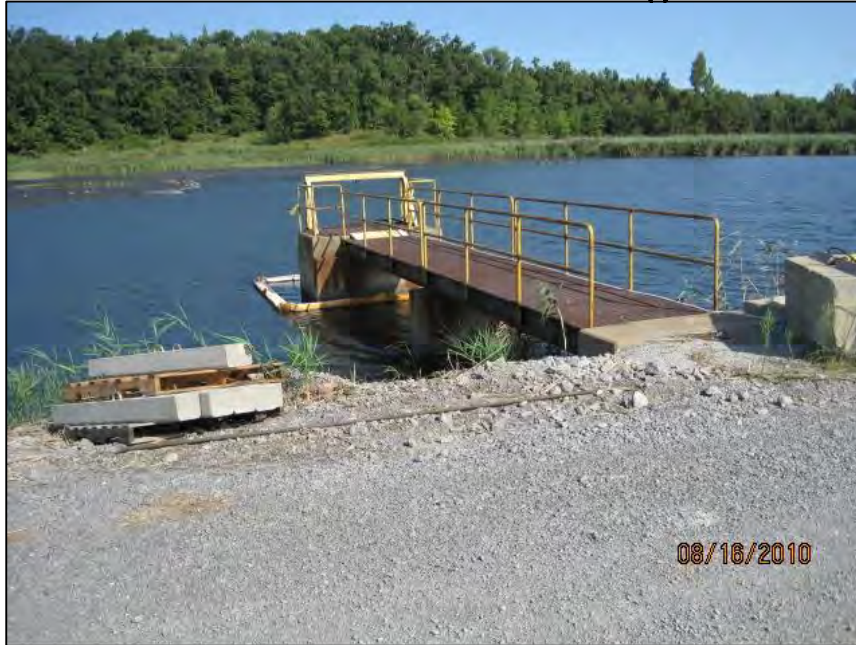
M-13

The ash pond has a side-hill configuration; and, a freeboard of approximately 4.5 feet between the top of water and top of dike was observed during the site visit (photo M-13). Original ground above the elevation of the pond is to the north. Dikes are present on the west, south and east sides of the pond. The crest of the dam and upstream slopes of the west and south dikes were primarily surfaced with crushed stone (photos M-1, M-6, M-8, and M-17). The surface of the downstream slopes of the dikes and the upstream slope of the east dike was primarily covered with grass (photos M-2, M-5, and M-17). Sparse grass cover was observed on the downstream slope of the west dike (photo M-2). Ash was observed to be stacked to a height just below the crest of the south dike at the southwest end of the pond (photo M-3). Two above ground pipes for sluicing ash to the pond are located on the west portion of the south dike. The pipes traverse the downstream slope of the south dike then cross the crest through a concrete culvert (photos M-25 and M-8). Two buttresses, reportedly installed due to shallow surface failures, were observed on the downstream slope of the south dike, one on the west (compacted soil construction) and one on the east (rock construction) portions of the dike (photos M-9 and M-12). The buttresses reportedly include drains which are tied to a collector pipe and directed to the toe of the slope. Flowing water was observed from the outlet of the west buttress; however, flowing water was not observed at the east outlet (photos M-24 and M-21). Sparse grass cover and uneven slopes were observed on the mid-section of the downstream slope of the south dike beginning at the west buttress and extending for about 300 feet to the east (photo M-23). A stockpile of sand and gravel was observed at the north end of the east dike (photo M-20). Trees appeared to be growing within the interior at the northeast end of the pond, but they may be growing on fingers of original ground extending into the interior from the north (photo M-20). Old matting and straw was observed on the downstream slope of the west dike. Reportedly, the slope was seeded and matted last fall but weather killed most of the planting. Kentucky Utilities stated they had bid out a contract to reseed the slopes this fall.

LOOKING NE AT OUTLET STRUCTURE, PERIMETER SKIMMER AND POND INTERIOR TO NATURAL HILLSIDE IN BACKGROUND, STACK OF CONCRETE STOP LOGS IN FOREGROUND

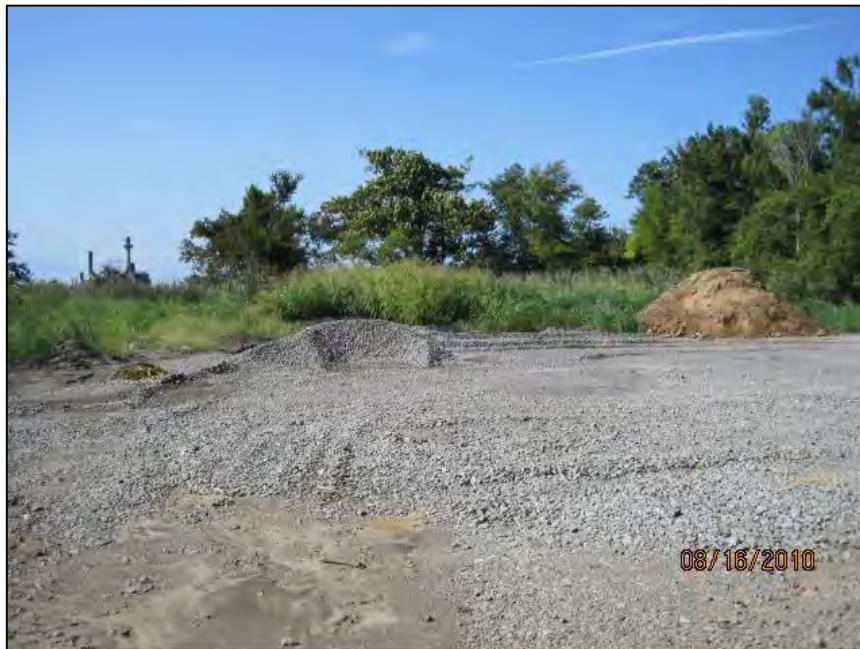
M-20

**GRAVEL AND SAND STOCKPILE AT NORTH END OF EAST DIKE. TREES APPEAR TO BE GROWING IN POND INTERIOR.
TREES COULD BE GROWING ON FINGER OF ORIGINAL HILLSIDE**

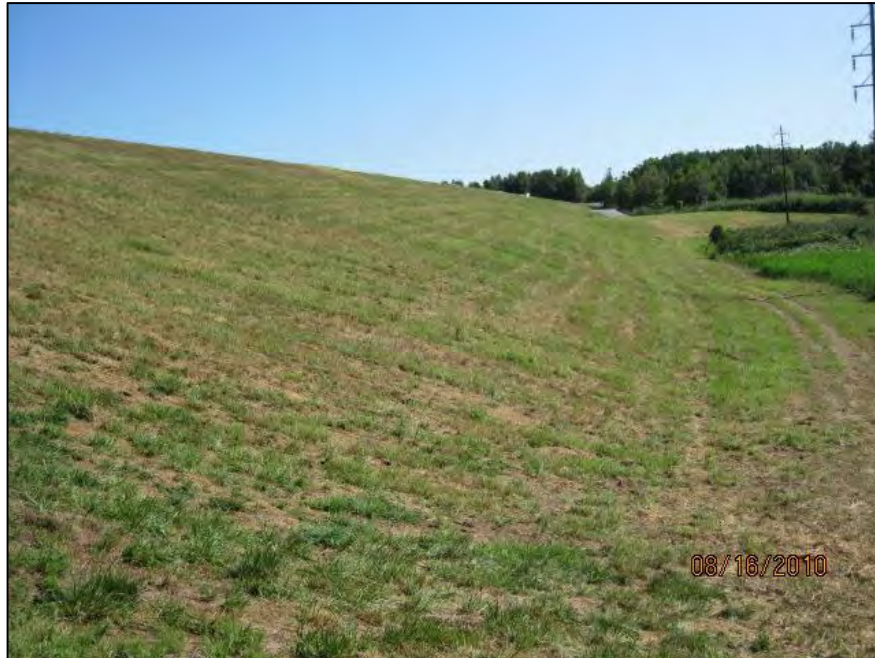
M-23

**LOOKING EAST ON SOUTH DIKE, UNEVEN SLOPES AND SPARSE GRASS ON DOWNSTREAM
SLOPE FROM WEST BUTTRESS TO ABOUT 300 FEET EAST**

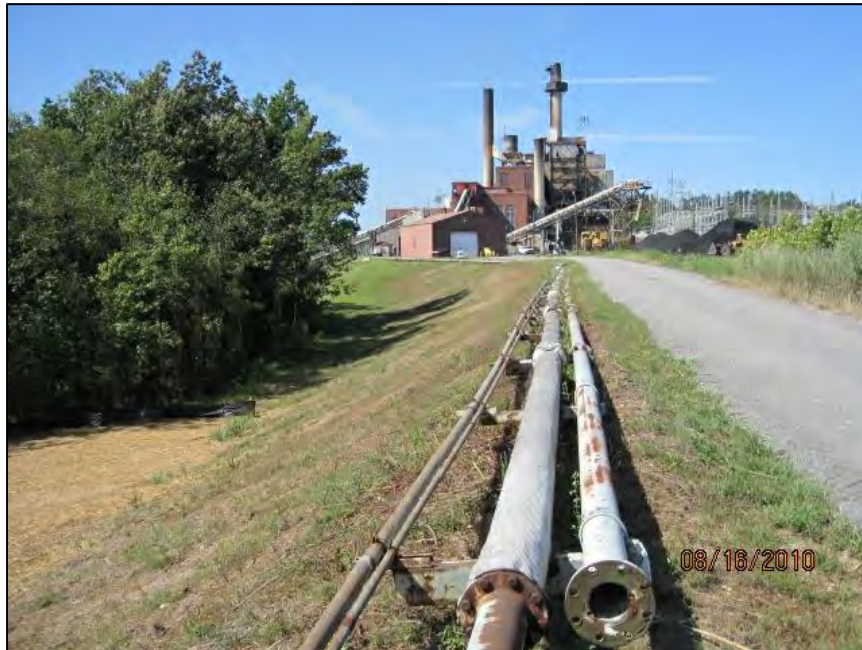
CR-1

LOOKING W AT SOUTH DIKE (ROAD), EROSION, SPARSE GRASS, STEEP SLOPE

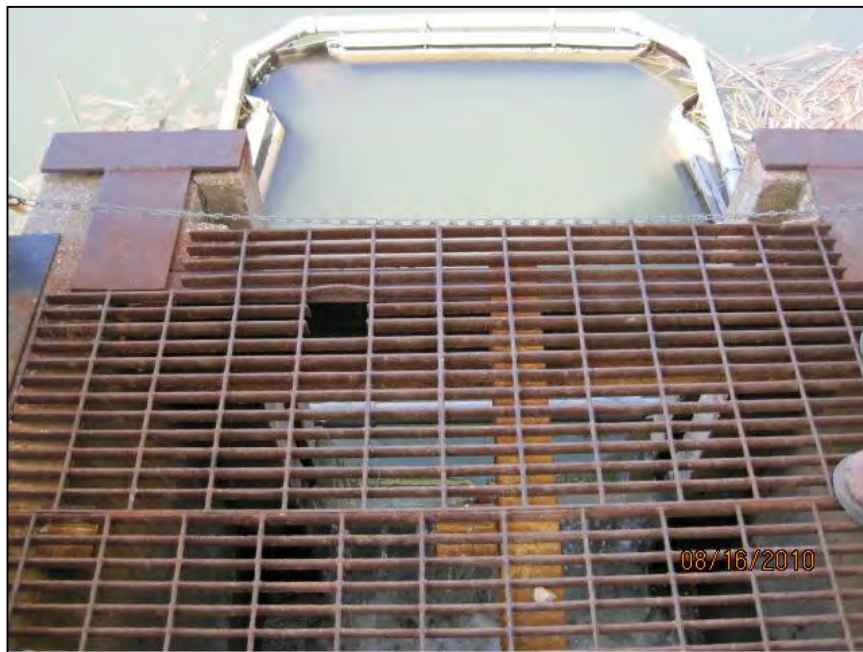
2-12

METAL AND RUBBER SKIMMER AND INTAKE, SILT CLEANED APPROX. EVERY 5 YEARS

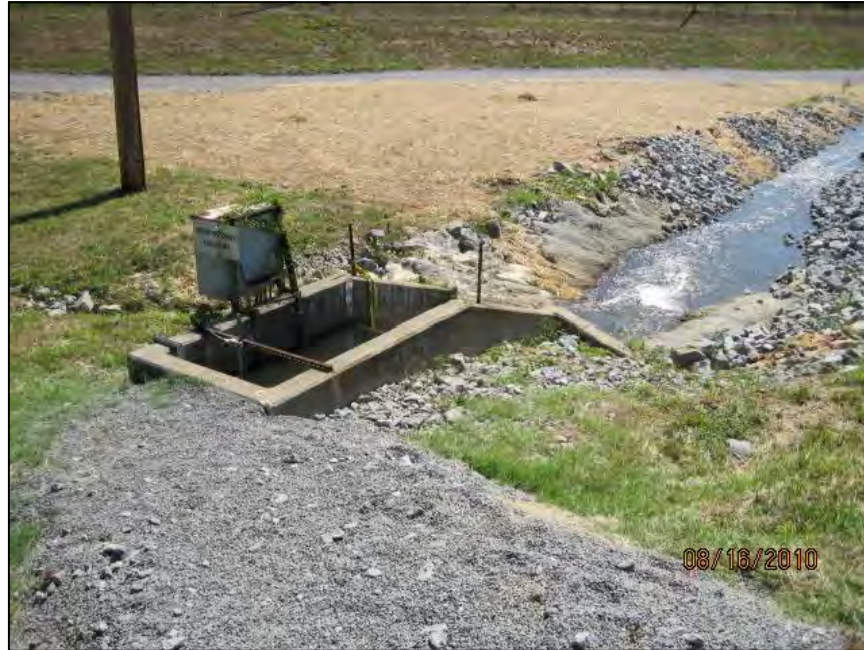
2-13

LOOKING SW AT NPDES OUTFALL 001, BACKGROUND: SPARSE GRASS ON DOWNSTREAM SLOPE OF SCRUBBER POND WEST DIKE

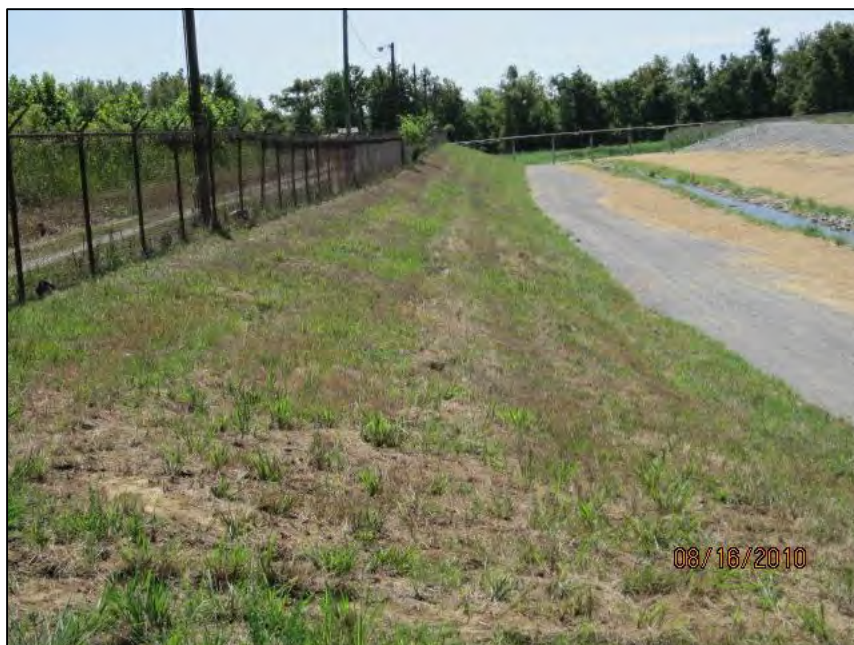
SP-8

LOOKING W AT EAST DIKE DOWNSTREAM SLOPE, STEEP AND AREAS WITH SPARSE VEGETATION

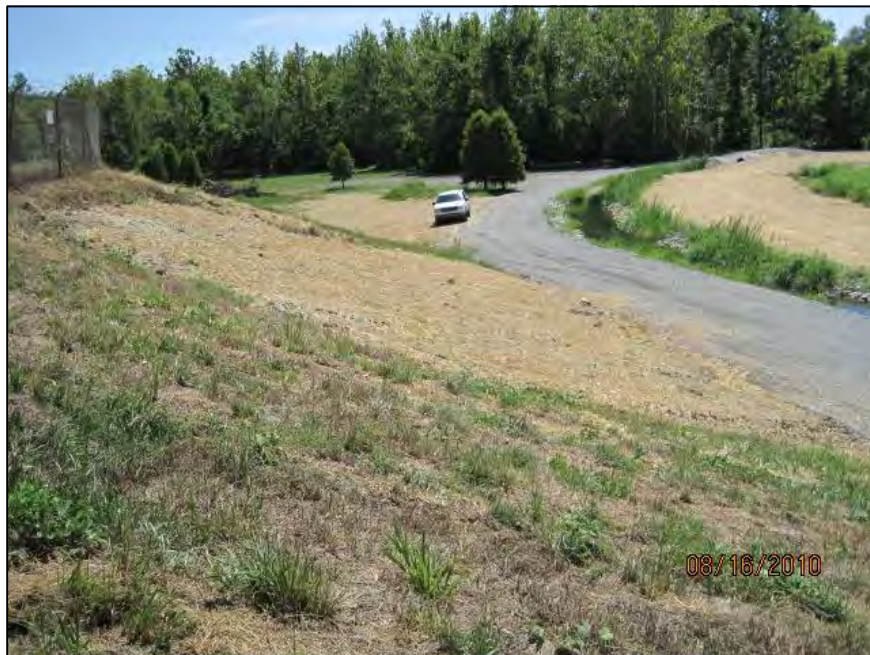
SP-10

LOOKING SE AT SOUTHWEST CORNER DOWNSTREAM SLOPE, SHALLOW SURFACE SLIDE REPAIR

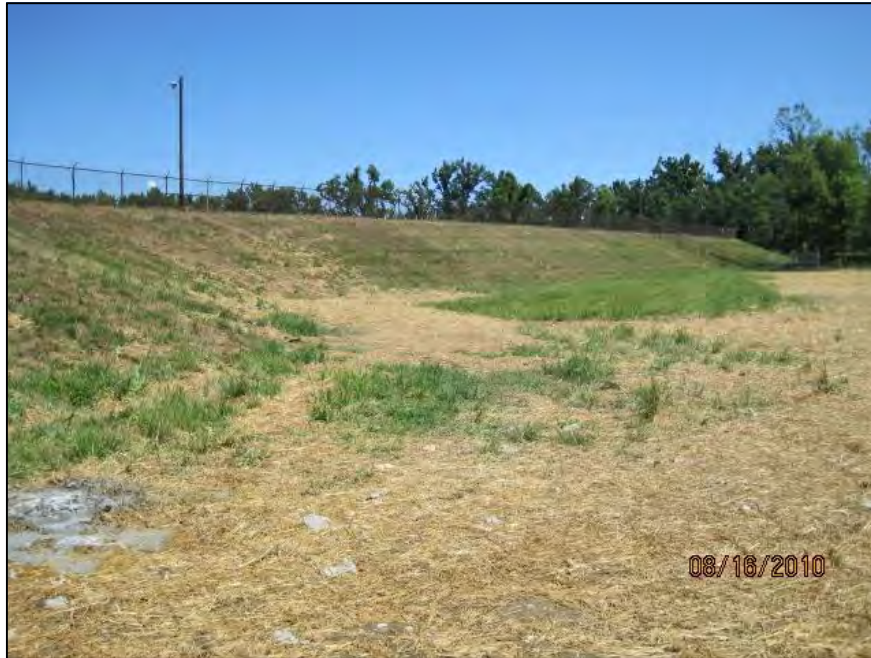
SP-11

**LOOKING E AT DOWNSTREAM SLOPE OF SOUTH DIKE, WET AREA BELOW TOE,
STEEP SLOPE, SPARSE GRASS**

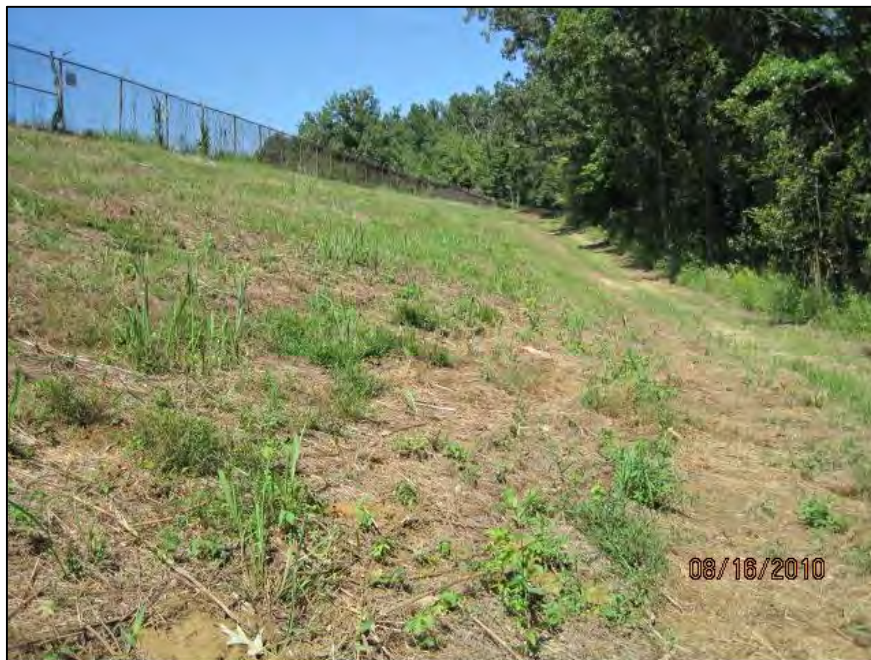
SP-12

LOOKING NE AT DOWNSTREAM SLOPE OF SOUTH DIKE, STEEP SLOPE, SPARSE GRASS
